# **INDOOR AIR QUALITY ASSESSMENT**

**Essex County Superior Court  
43 Appleton Way  
Lawrence, MA**

Prepared by:  
Massachusetts Department of Public Health  
Bureau of Environmental Health  
Indoor Air Quality Program  
August 2018

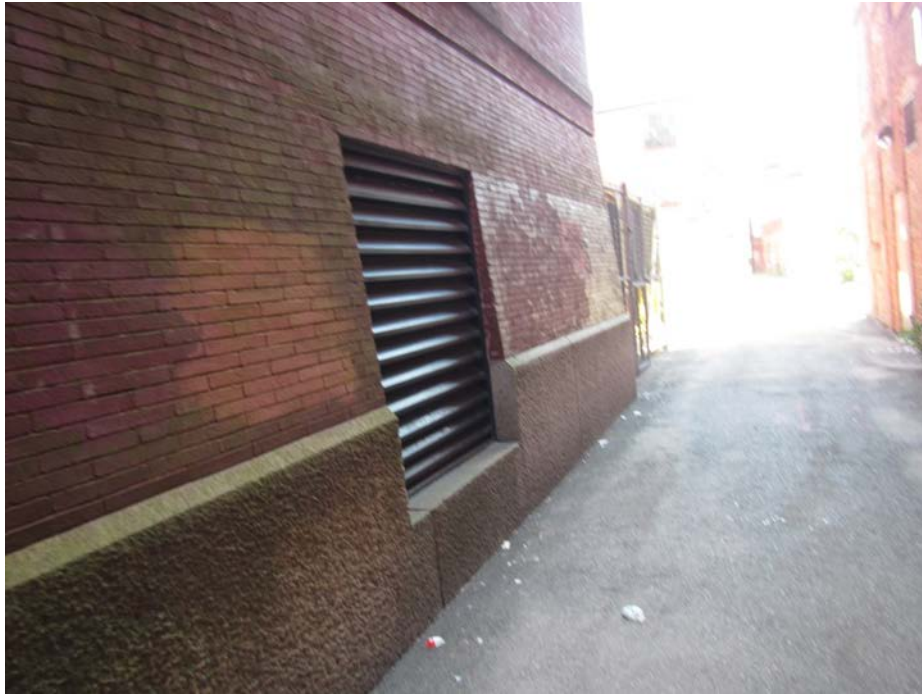
**Picture 1**

Fresh air is provided by air handling units (AHUs) located in mechanical rooms in the basement and attic. Fresh air is drawn into the AHUs via vents in the outside of the building (Pictures 1 and 2). Air from the AHUs is filtered, heated/cooled and delivered to rooms via ducted supply vents (Picture 3). Stale air is drawn into ceiling-mounted return vents (Picture 4) and is returned to the AHUs through the ceiling plenum.

**Air intake on side of the building in alleyway**

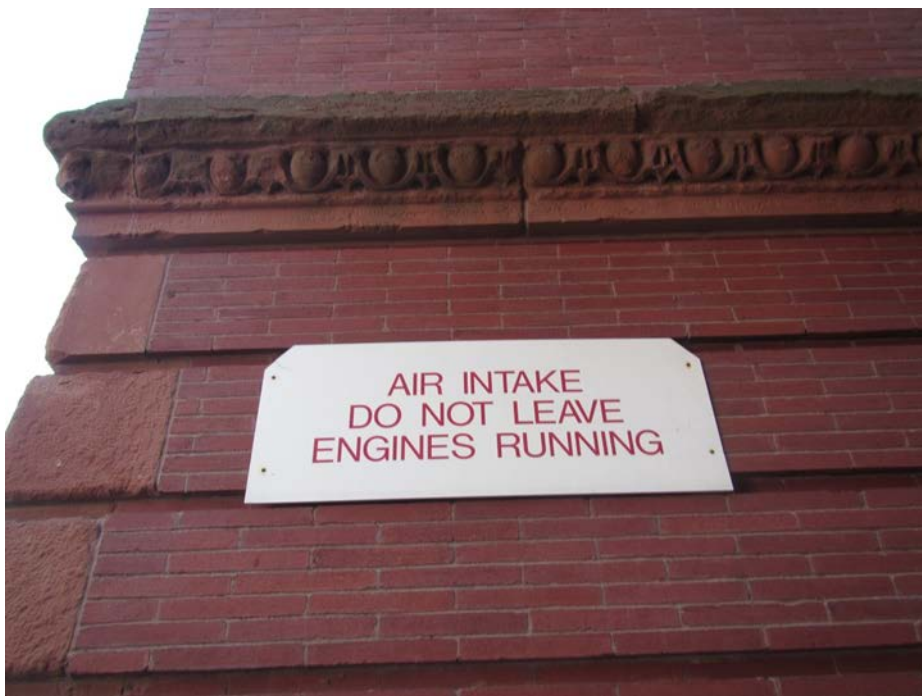
**Picture 2**

The fresh air intake in the alley to the rear of the building is susceptible to pollutants being drawn in from idling vehicles, stored garbage, smoking or other sources (Picture 2). Signs which say “no vehicle idling” and “no smoking within alley” with listed fines may be more effective to improve compliance. Note that M.G.L. c. 90:16A restricts idling of vehicles to no more than five minutes unless absolutely necessary (MGL, 1996). Also, since the alley way has enclosed walls and includes the fresh air intake, it may be considered an extension of the building itself where smoking is prohibited.

**Sign in alleyway next to air intake**

3. Avoid idling of vehicles in the alley of the building near the air intakes in accordance with M.G.L. c. 90:16A which restricts idling of vehicles to no more than five minutes unless absolutely necessary (MGL, 1996).

4. Install more explicit signs stating laws and fines in the area of the fresh air intake in the alley to minimize noncompliance and pollutant entrainment in this area. Monitor for compliance and enforce as necessary. This would also include no smoking enforcement.

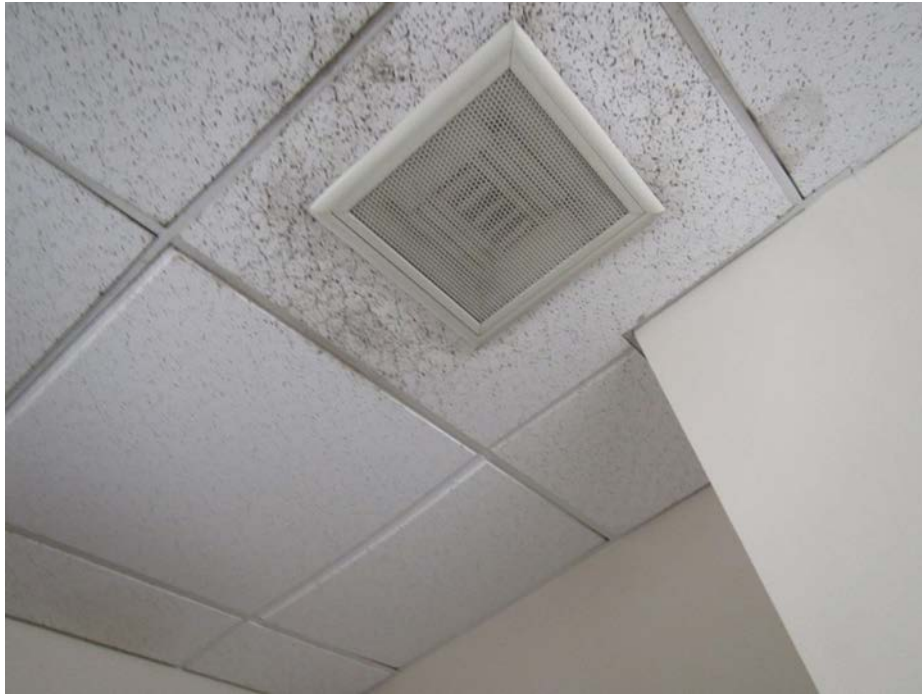
**Picture 3**

Food and food crumbs were observed in some areas (Picture 18). Cooking /eating equipment and areas should be kept clean to prevent attracting pests and creating smoke and odors. Plaster dust and peeling plaster and paint were observed in many areas (Picture 19; Table 1). Dust can become airborne and be a source of irritation. Cleaning of plaster dust and repair of damaged plaster should be conducted regularly to prevent dust. Supply and return vents and adjacent ceiling tiles were also dusty in some areas (Picture 3) and should be cleaned periodically.

**Typical supply vent, note dust/debris**

24. Clean vents and personal fans periodically.
25. Reduce accumulated materials and store in an organized manner to allow for thorough cleaning.
26. Clean carpeting in accordance with IICRC recommendations (IICRC, 2012).

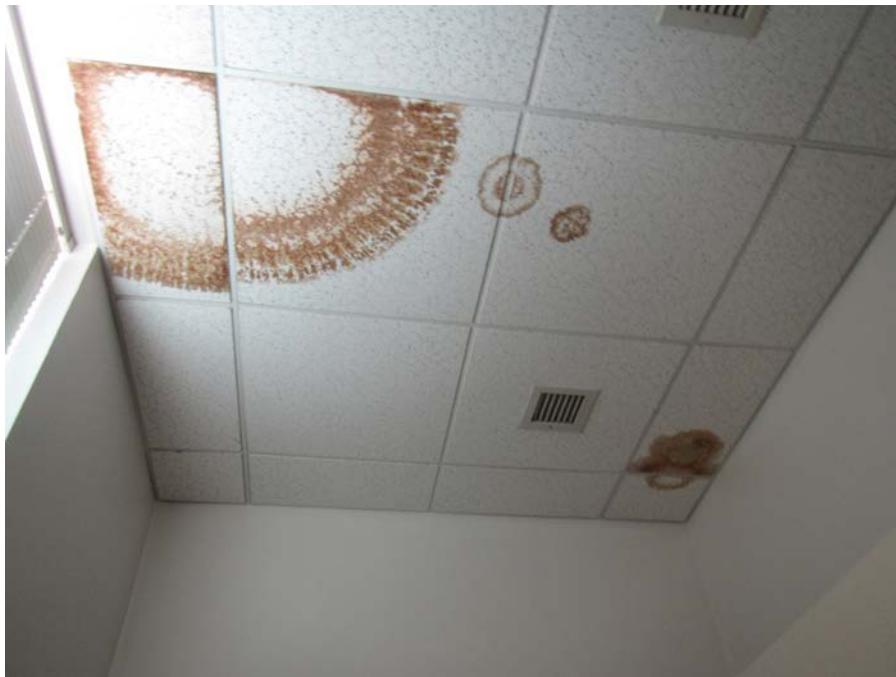
**Picture 4**

Water-damaged ceiling tiles were observed in several places (Pictures 4 and 11; Table 1), with some appearing to be colonized with mold. It was reported that the roof has active leaks on the third floor. Most other stained ceiling tiles were reported to be from leaking/corroded bleed valves from the HVAC system. Water-damaged ceiling tiles can provide a source of mold and should be replaced after a water leak is discovered and repaired. ECSC facilities staff stated that future capital improvement projects will address roof repairs and new chillers for the HVAC system.

**Return vent, note water-damaged ceiling tiles**

15. Repair roof/plumbing leaks (e.g., bleed valves) and replace water-damaged ceiling tiles.

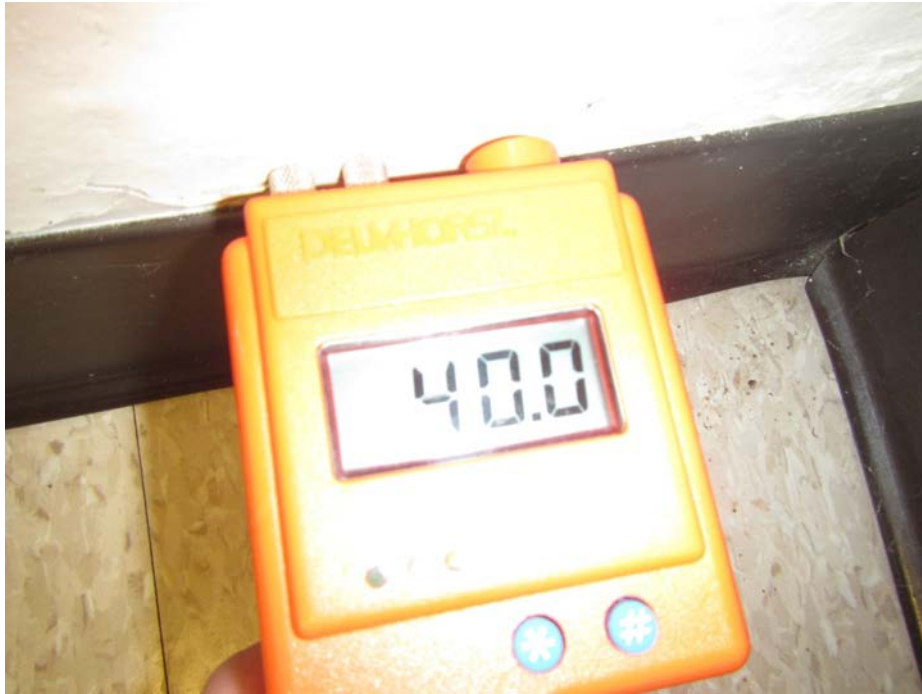
**Picture 5**

The basement has a section that is currently unoccupied on the north side abutting Common Street. This area has had water infiltration in the past and had recently been remodeled including new gypsum wallboard (GW). GW abutting the north wall had measureable levels of moisture in most of this area (Picture 5; Table 1) and showed other signs of water damage, including damaged paint (Picture 6) and peeling coving. In addition, floor tiles were buckling (Picture 7) which may be the result of water infiltration or condensation on the concrete floor. The relative humidity measurements in the lower level were *above* outdoors (Table 1) which is an indicator that there is a source of moisture in this space. Gypsum wallboard and some coving have paper components that can become colonized with mold if moistened long enough, or repeatedly. Paint, debris on wall, and carpet may also become mold-colonized.

**Measurement of moisture indicating wall is moist**

7. Remove any porous building materials in the lower level that were water-damaged and not properly dried within 24-48 hours as recommended. This would include any gypsum wallboard, paper-backed insulation, and carpeting. Remediate any water-damaged materials in accordance with the US EPA guidance “Mold Remediation in Schools and Commercial Buildings” (US EPA, 2008).

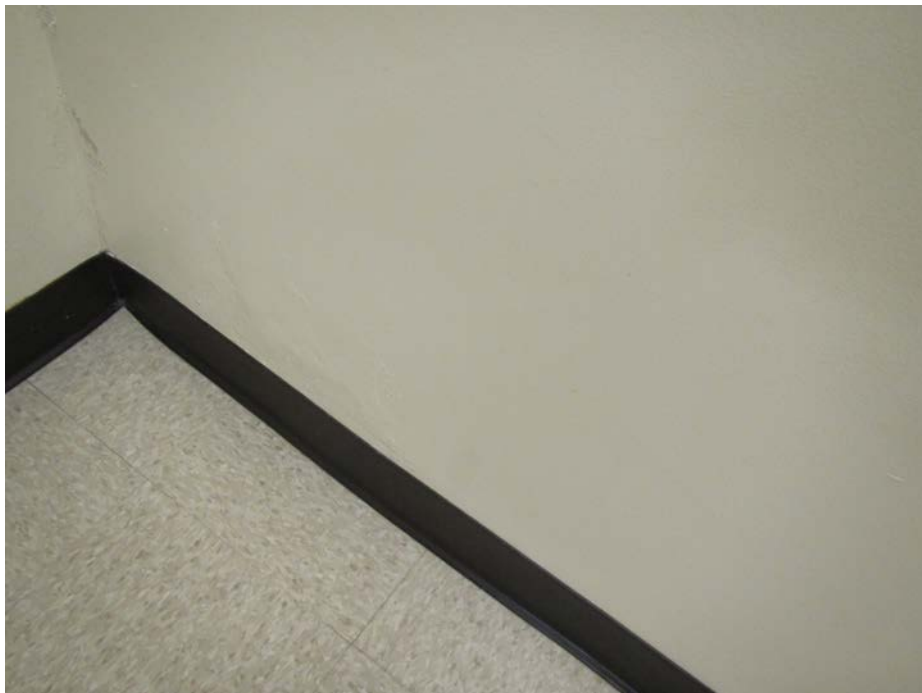
**Picture 6**

**Bubbled/damaged paint**

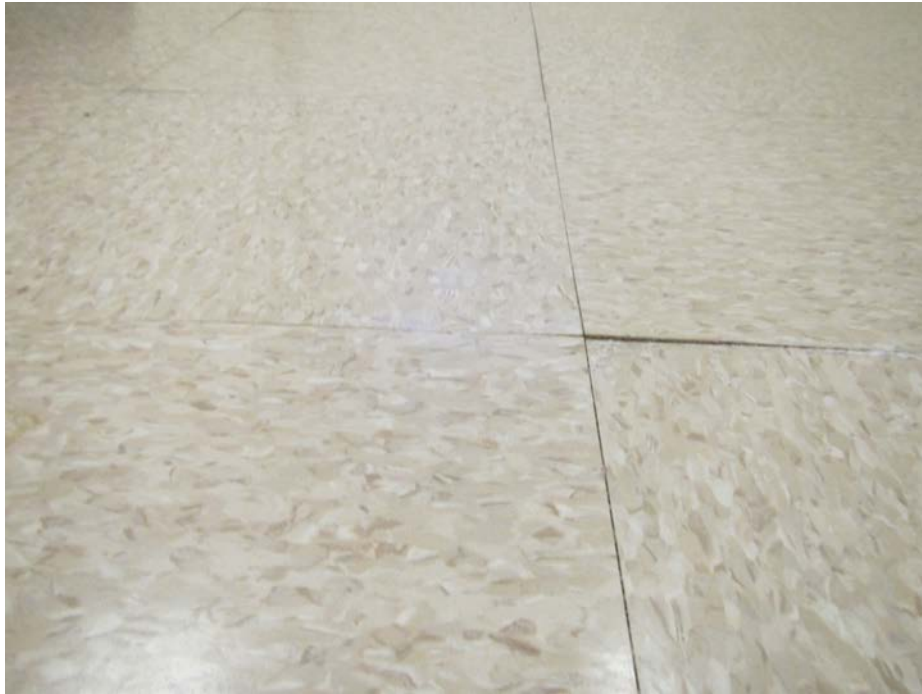
**Picture 7**

**Buckled/delaminated floor tiles**

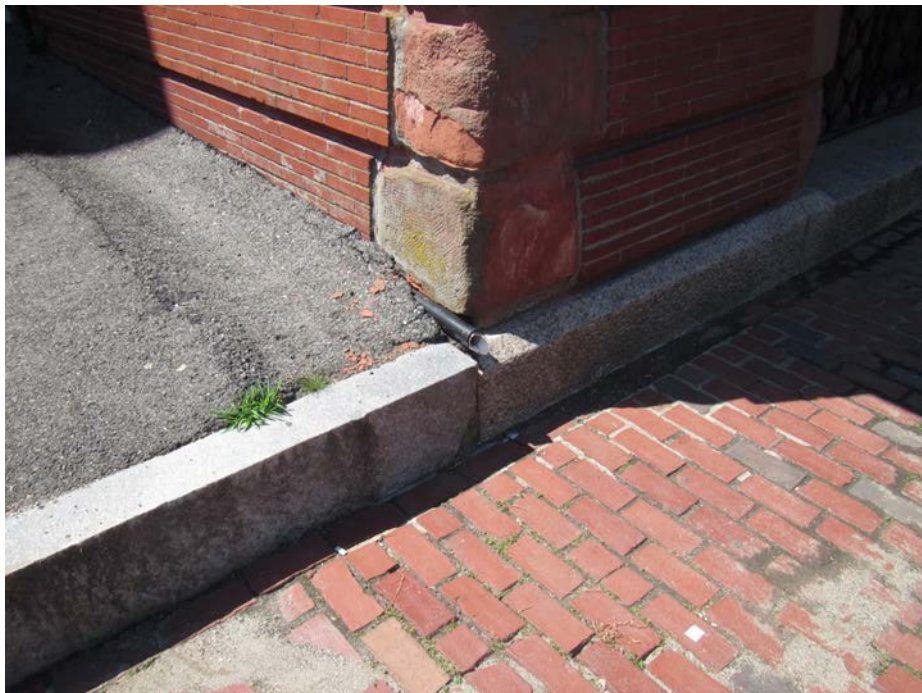
**Picture 8**

Some work has reportedly been done to address drainage problems on this side of the building, including the installation of a sump pump and drain (Picture 8); paving over and sloping what had been a vegetated setback area along Common Street (Picture 9); and repairs to the foundation. While these efforts have reportedly reduced infiltration significantly, there is still water penetration below grade, particularly during heavy rains. Due to the age and construction of the building, it may be difficult to completely waterproof the foundation, but additional steps may be helpful. These may include: repairs to the sidewalk along the Common Street side to reduce infiltration and resetting the slope to drain away from the building (Picture 10), re-grading any other areas next to the foundation wall; extension of the sump pump drain line to remove water further away from the building; and additional repair/waterproofing of the exterior foundation wall, including ensuring any weep holes are operational to drain water from the wall drainage plenum.

**Sump pump drain pipe, note discharge directly against wall**

8. Discard any unneeded water-damaged stored materials. Any irreplaceable documents may require professional restoration.
9. Continue with plans to make additional repairs to exterior drainage, sidewalk slope, and waterproof the exterior.

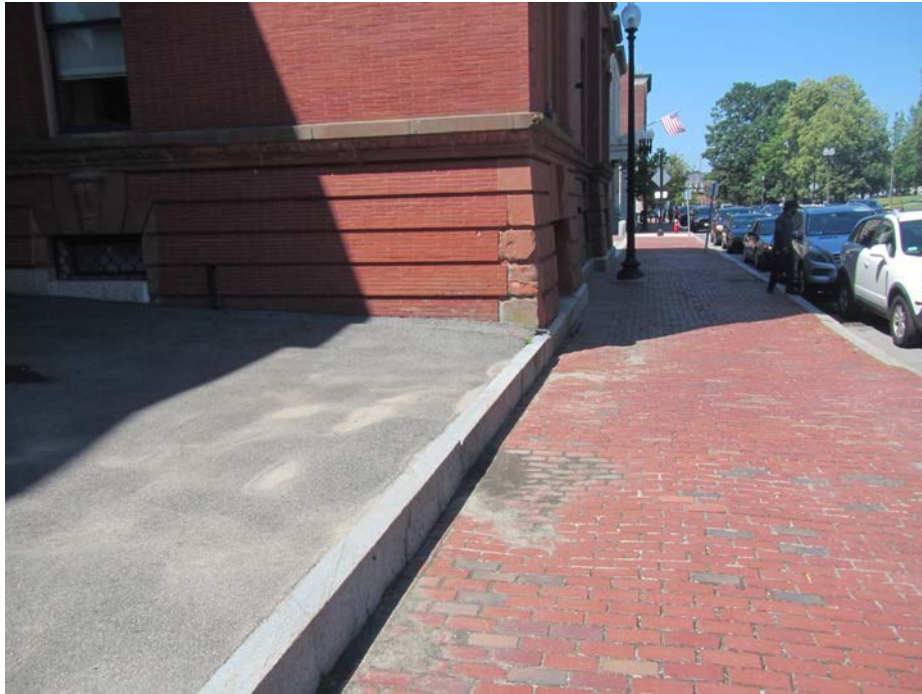
**Picture 9**

**Paved area (left side of picture) which used to be vegetated, sloped away from the building**

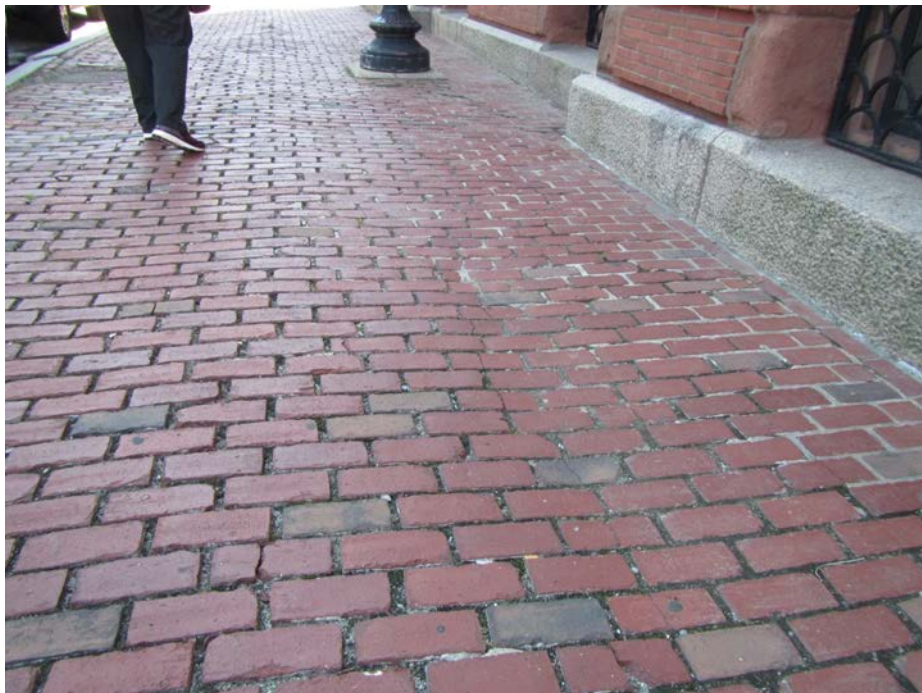
**Picture 10**

**Sidewalk between building and Common Street, note lack of smooth slope away**

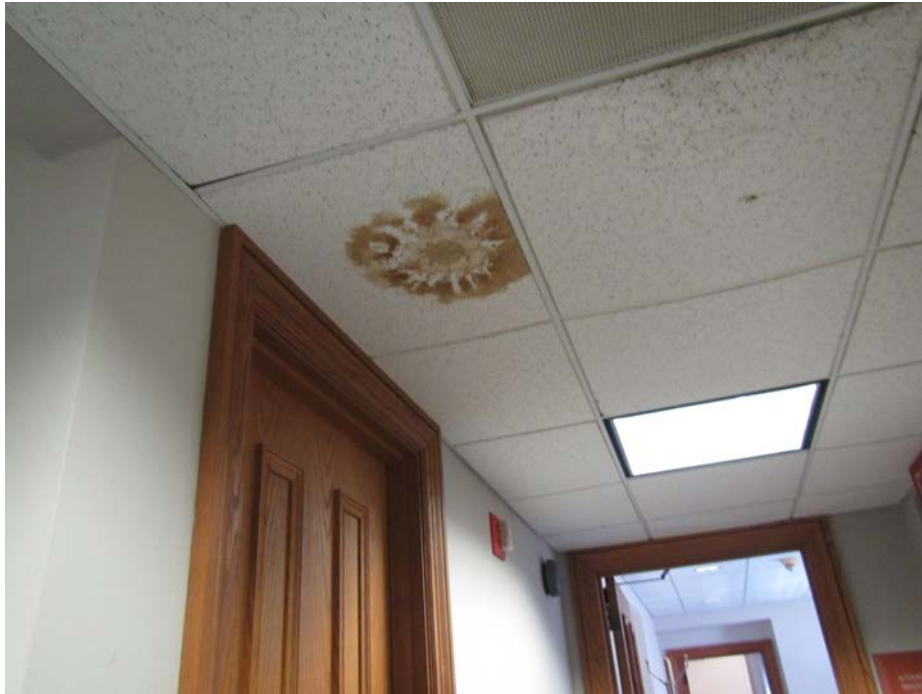
**Picture 11**

**Water-damaged ceiling tile with possible mold colonization**

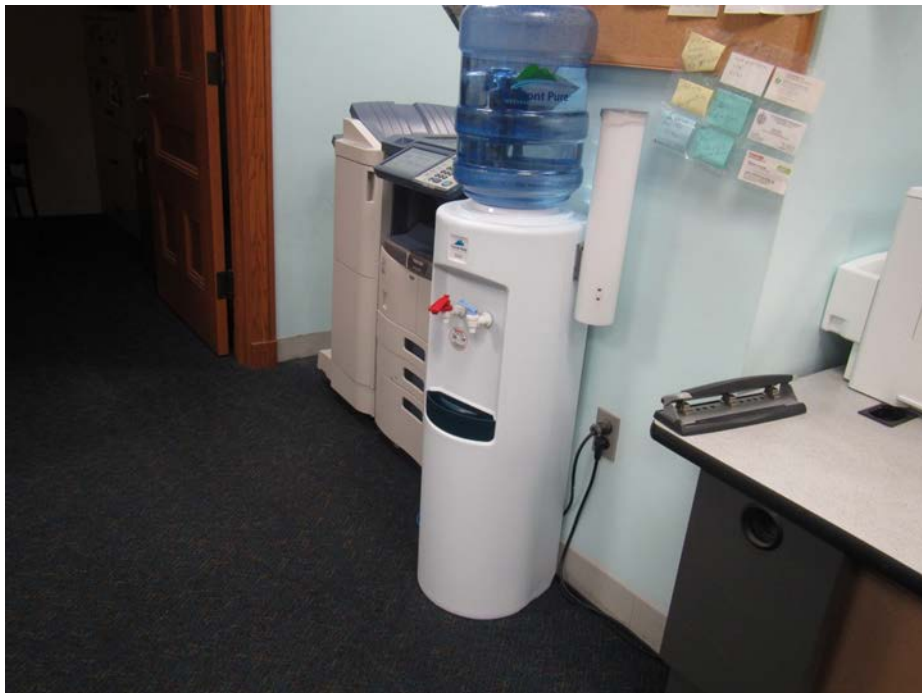
**Picture 12**

**Water cooler on carpet**

17. Keep plants in good condition, avoid overwatering, and avoid placing them on porous items such as carpets or paper.
18. Consider locating water coolers and refrigerators in areas without carpet, replacing the carpet in these areas with non-porous flooring, or using waterproof mats to protect carpeting.

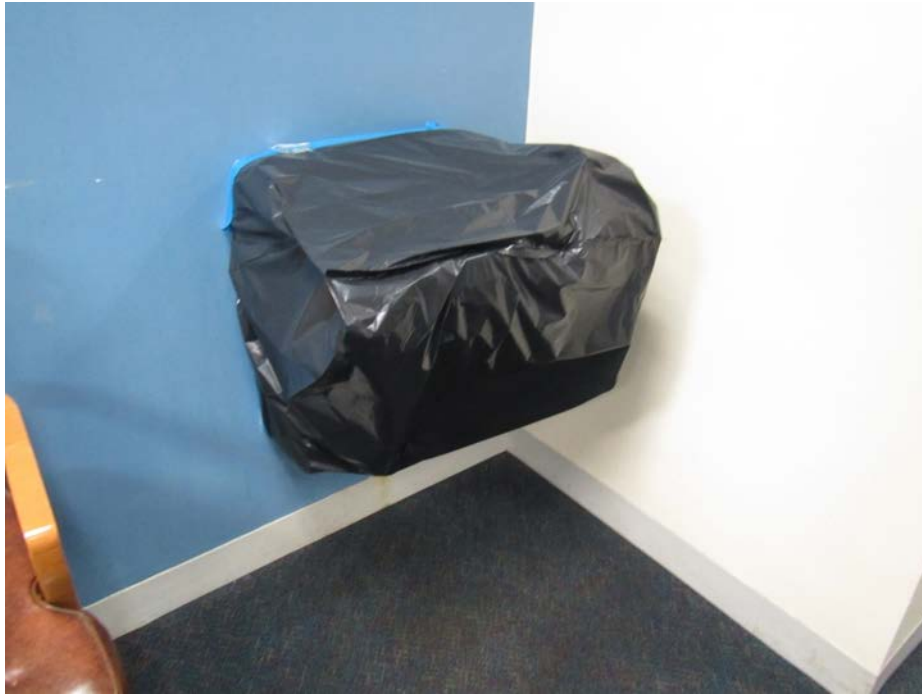
**Picture 13**

A water fountain on the lower level was out of order and covered in plastic (Picture 13). A sink and toilet in another office were also disconnected from the water supply. Unused or broken plumbing can be a source of leaks. In addition, unused/unusable fixtures can allow for dry drain traps, which can be a source of sewer gas, moisture and odors to occupied spaces.

**Broken water fountain in Probation Department area**

Plumbing fixtures should be repaired promptly or properly capped, and any unused drains should be periodically filled with water to maintain the trap seal.

19. Repair broken plumbing fixtures or have them properly cut and capped to prevent leaks. Ensure unused or infrequently used drains are watered regularly to maintain the trap seal and prevent infiltration of sewer gases and odors into occupied space.

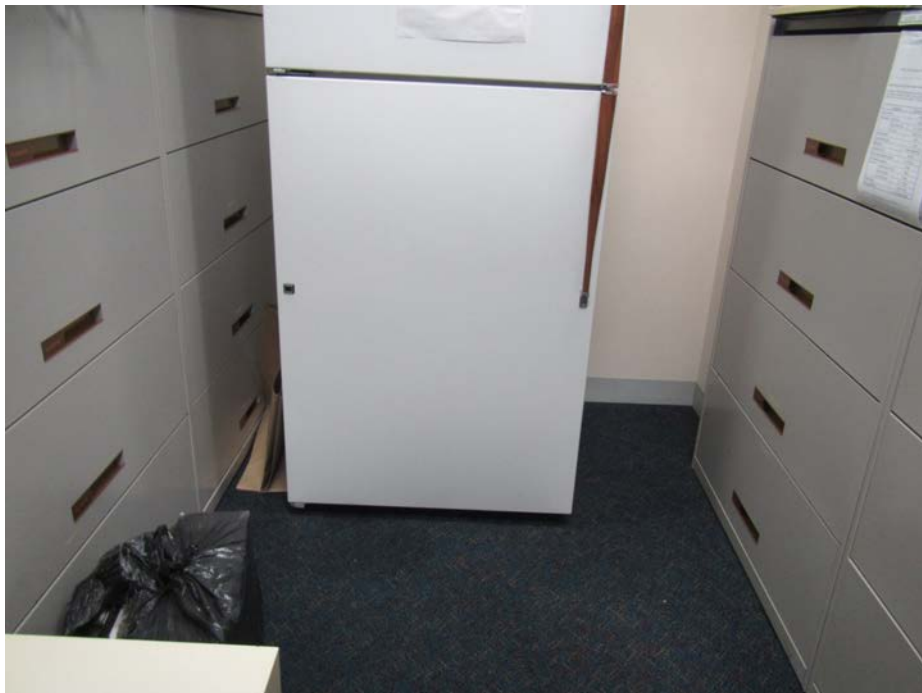
**Picture 14**

**Refrigerator in carpeted area**

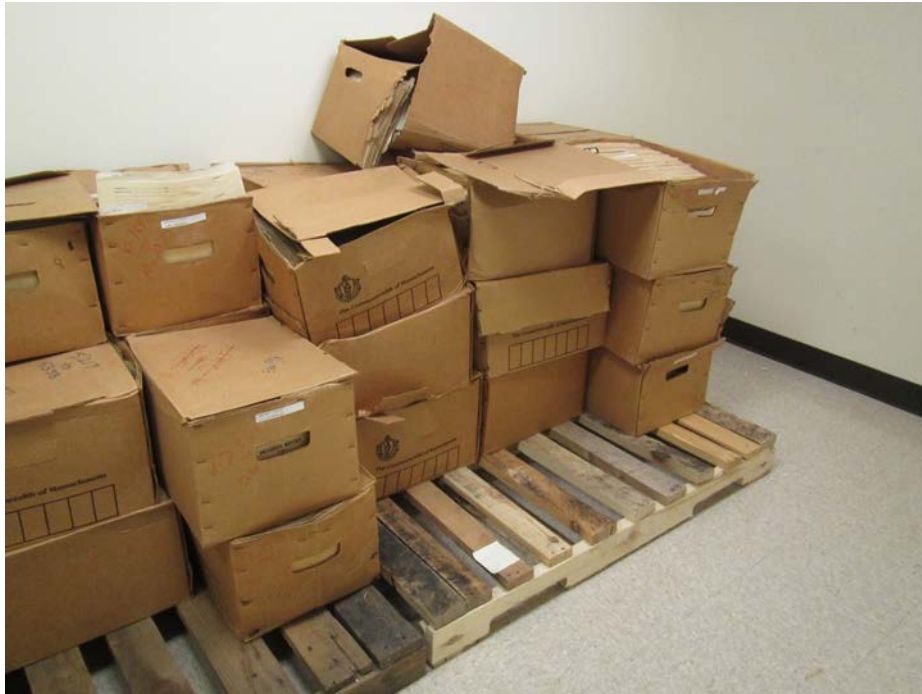
**Picture 15**

There was a stack of boxes in the unused area on the lower level that were up on pallets, but had been water-damaged in the past (Picture 15). Water-damaged paper materials should be sorted and either professionally restored, copied to fresh paper or discarded as they may be colonized with mold or a source of odors.

**Water-damaged boxes in the lower level**

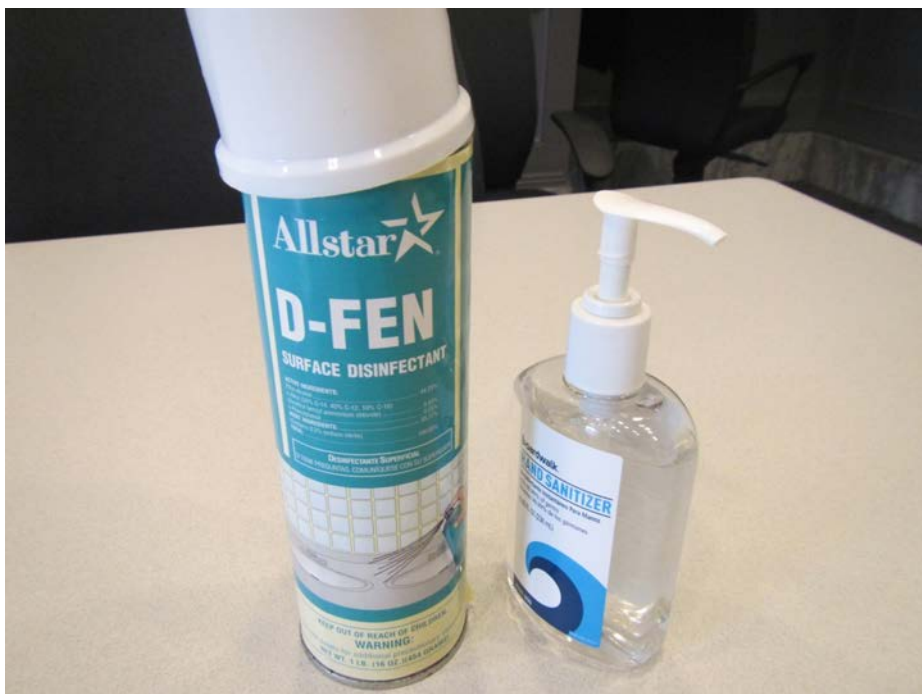
**Picture 16**

**Disinfectant and hand sanitizer**

20. Reduce the use of VOC-containing cleaners and sanitizers and avoid the use of air fresheners and scented candles.
21. Use the principles of IPM to reduce pest issues in the building, including the sealing of pathways and reduction in sources of food and harborage. Consult "Integrated Pest Management Kit For Building Managers" (MDFA, 1996), <http://www.mass.gov/eea/docs/agr/pesticides/publications/ipm-kit-for-bldg-mgrs.pdf>.

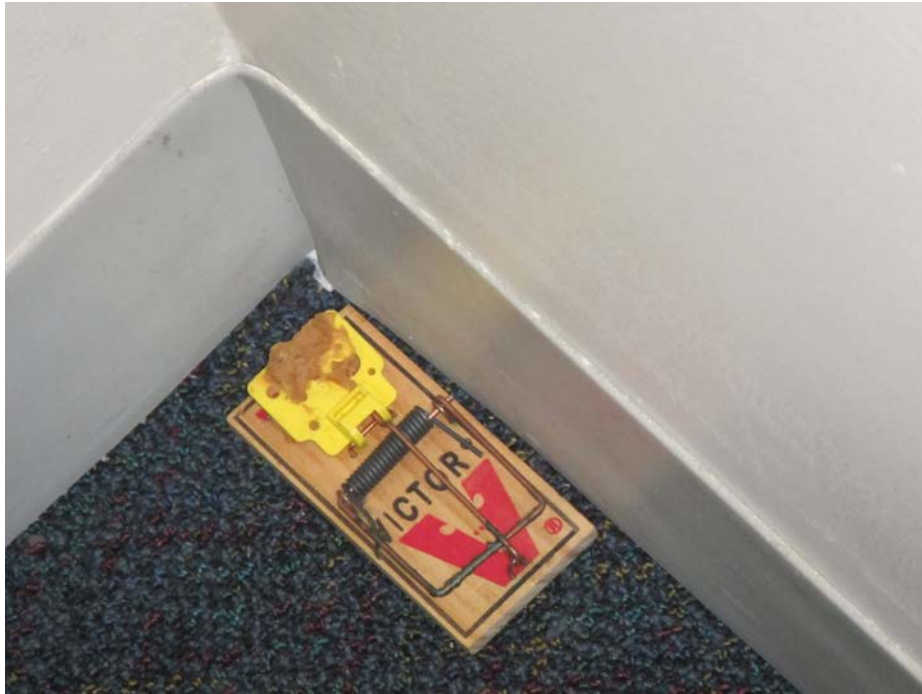
**Picture 17**

BEH/IAQ staff noted the presence of rodent traps in some areas (Picture 17). Rodents and rodent wastes are a common allergen. The principles of Integrated Pest Management (IPM)

**Rodent trap in occupied space**

should be used to reduce incidence of rodents, including removing/containing food and food waste, removing access to water and harborage, and reducing pathways for rodents to travel into and through the building. Note that after rodents have been removed from the building, thorough cleaning is required to remove rodent-related allergens. ECSC staff reported that the building is under contract with a pest control company. The document “Integrated Pest Management Kit for Building Managers” provides additional strategies for IPM (MDFA, 1996).

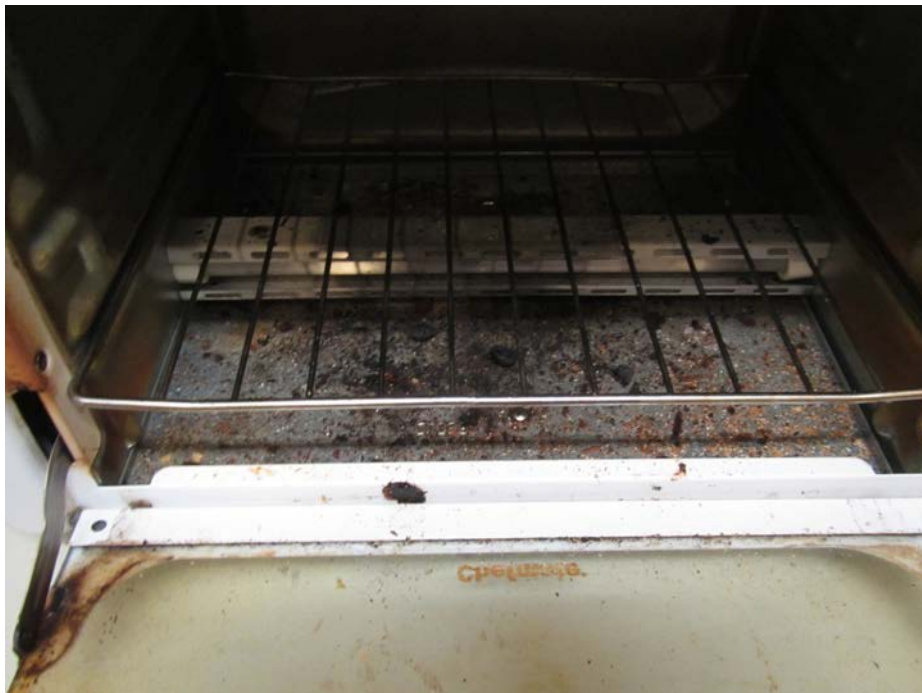
**Picture 18**

**Toaster with crumbs**

22. Clean food preparation areas and equipment regularly to remove debris that may be a source of odors and attractive to pests.
23. Clean/repair damaged plaster and peeling paint periodically to remove loose material that can become airborne.

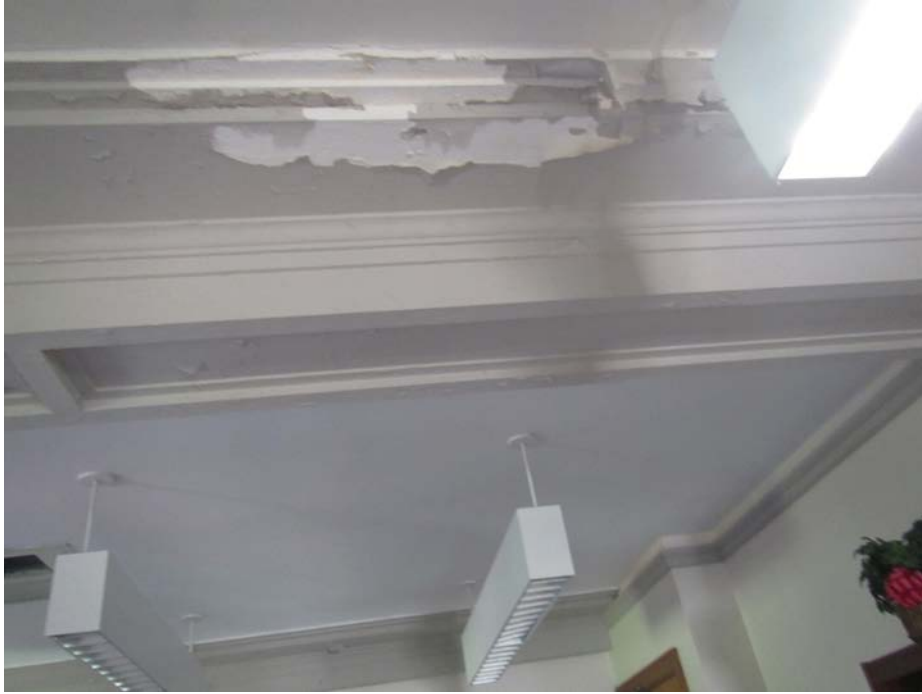
**Picture 19**

**Peeling paint on ceiling**
